New York State Department of Transportation General Bridge Inspection Report

Inspection Date: June 18, 2019

BIN: 3305810

Feature Carried: COUNTY ROAD 153

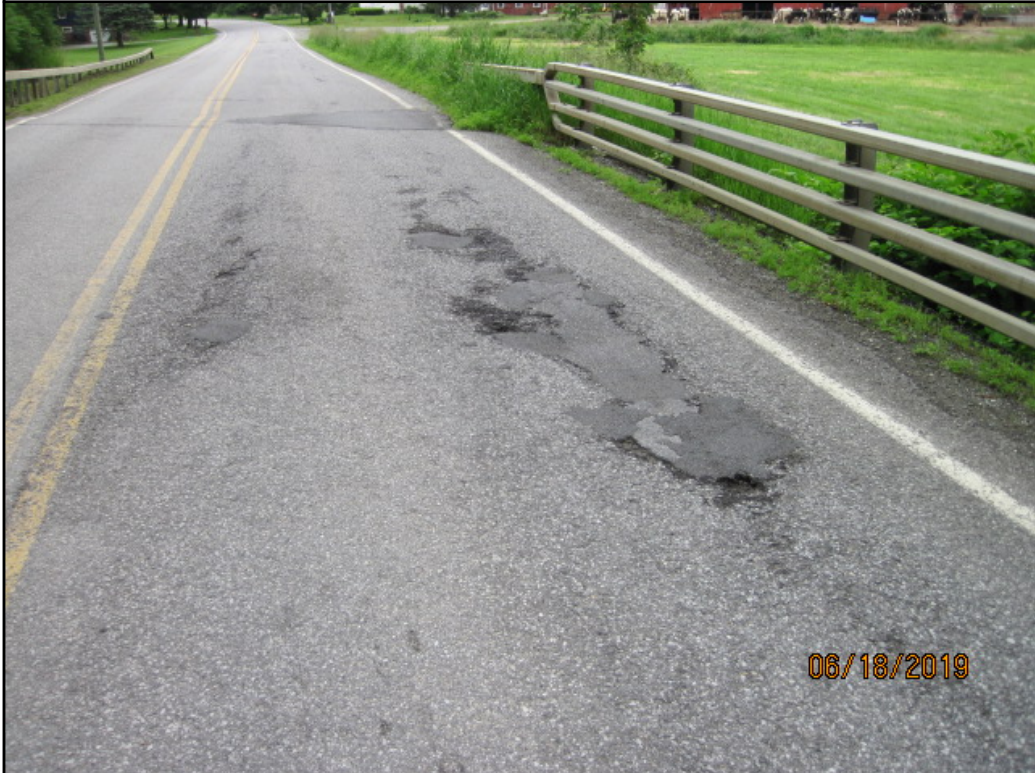
Photo Number: 1

Span 1: 60 - Other Deck-510 - Wearing Surfaces	TQ	CS-1	CS-2	CS-3	CS-4	CS-5
	1425	0	1400	25	0	0
Condition State 3 Note Referenced Photo(s): 1 Referenced Sketch(es): None Asphalt wearing surface right side is rough, and scaled near centerline with some spalling up to 4'L X 1'W X 2"D. There is an old patch near the shoulder that is starting to unravel.						
Span 1: 107 - Steel Open Girder/Beam-515 - Steel Protective Coating	TQ	CS-1	CS-2	CS-3	CS-4	CS-5
	3375	0	1687	0	1688	0
Condition State 4 Note Referenced Photo(s): 9, 10 Referenced Sketch(es): None Steel protective coating (patina) on girders has large non-adhering flakes and delaminations on bottom flanges and beam ends, indicating that steel has some continuous surface rusting.						
Span 1: BA215 - Reinforced Concrete Abutment	TQ	CS-1	CS-2	CS-3	CS-4	CS-5
	78	0	55	23	0	0
Condition State 3 Note Referenced Photo(s): 2 Referenced Sketch(es): None Begin abutment is delaminated and spalled on most of its surface, worst at begin left where the spalling is up to 12'W X 8'H X up to 6"D. Condition is similar to 2018 inspection.

Attachment Description:
Left Wearing Surface Mid-Span

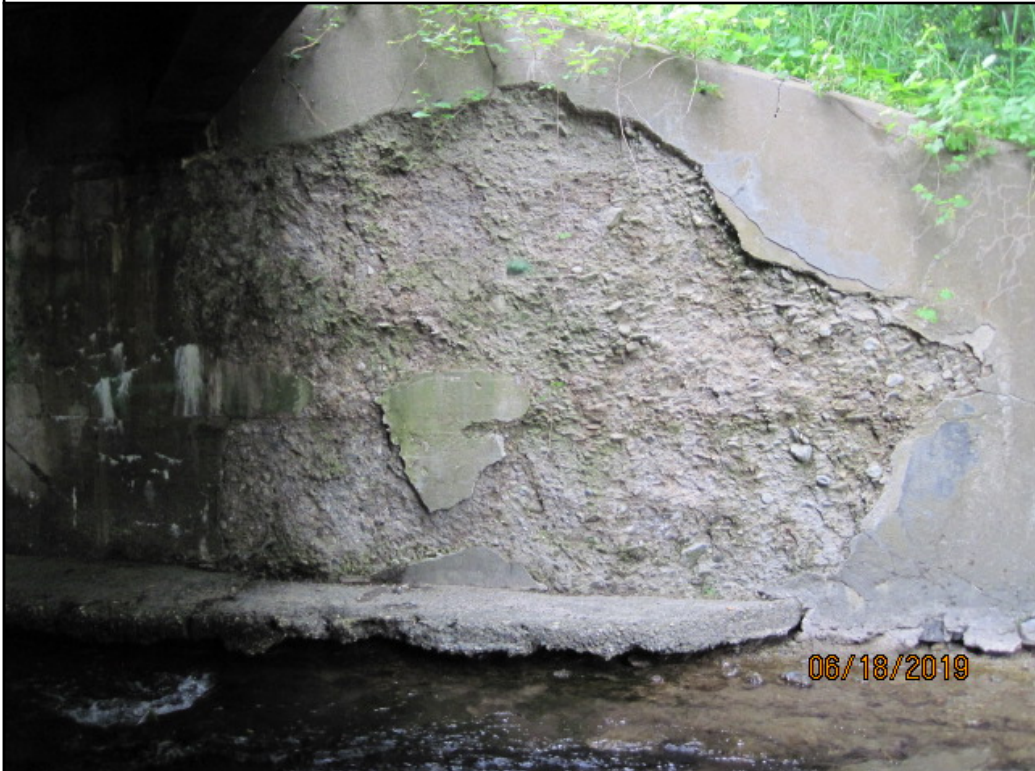
Photo Number: 2

Attachment Description:
Begin Left Abutment

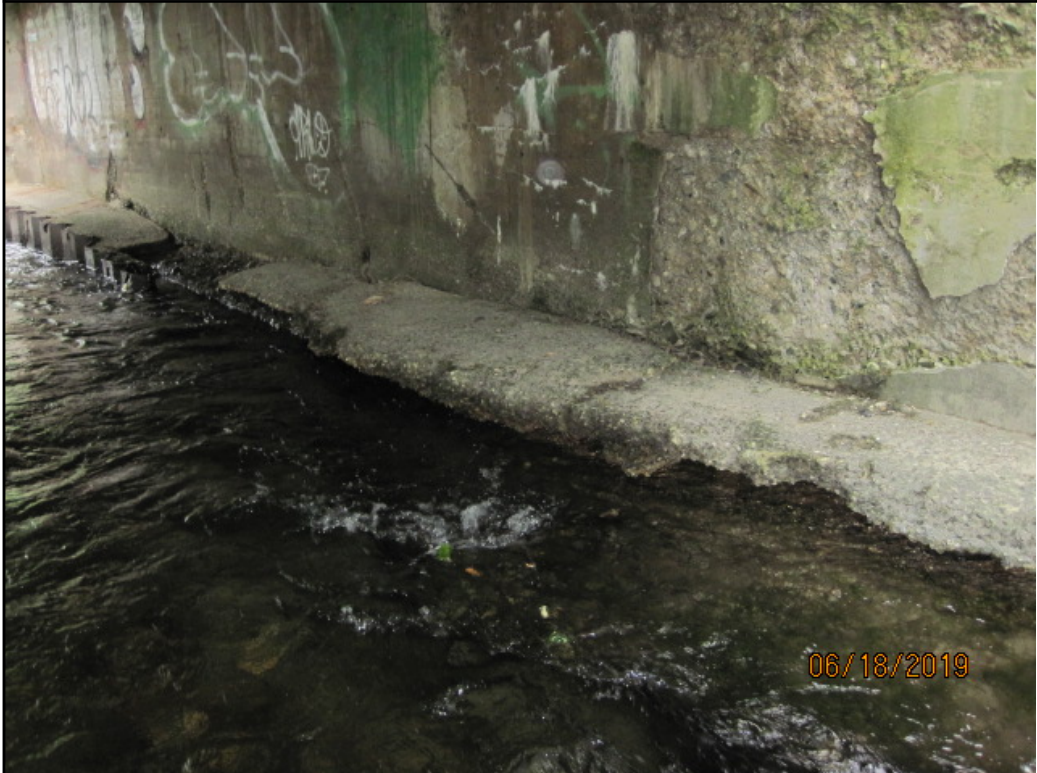
Photo Number: 3

Span 1: BA220 - Reinforced Concrete Pile Cap/Footing	TQ	CS-1	CS-2	CS-3	CS-4	CS-5
	79	0	51	27	0	1
Condition State 3 Note Referenced Photo(s): 3 Referenced Sketch(es): None						
Begin left abutment footing / overpour is exposed and exhibiting heavy delaminations with spalling up to full length x 6"D. The right side portion is protected by steel sheeting.						
Span 1: EA220 - Reinforced Concrete Pile Cap/Footing	TQ	CS-1	CS-2	CS-3	CS-4	CS-5
	77	0	0	77	0	0
Condition State 3 Note Referenced Photo(s): 15 Referenced Sketch(es): None						
End left and right abutment footings are heavily scaled / spalled up to 4"D on vertical and horizontal faces, with exposed aggregate. Near center of bridge the exposed footing is completely spalled to streambed X 25"W . Remaining concrete is solid.						
Span 1: BA800 - Erosion or Scour	TQ	CS-1	CS-2	CS-3	CS-4	CS-5
	79	0	14	65	0	0
Condition State 3 Note Referenced Photo(s): 3, 8 Referenced Sketch(es): None

The stream approaches towards the end left abutment and is redirected towards the begin abutment, causing scour along both of these areas. Worst scour is at the Begin Right Corner to a depth of 3.5'; steel sheeting protects this corner, no undermining. This is approximately 1' deeper than the 2018 inspection.						
Span 1: EA800 - Erosion or Scour	TQ	CS-1	CS-2	CS-3	CS-4	CS-5
	77	0	0	77	0	0
Condition State 3 Note Referenced Photo(s): 13, 15 Referenced Sketch(es): None						
Stream approaches towards the end left abutment and is redirected towards the begin abutment, causing scour along both of these areas. Scour is full abutment length X up to 1.5'D at the end left corner, no undermining.						
Span 1: BW800 - Erosion or Scour	TQ	CS-1	CS-2	CS-3	CS-4	CS-5
	15	0	5	10	0	0
Condition State 3 Note Referenced Photo(s): 8 Referenced Sketch(es): None						
The stream approaches towards the end left abutment and is redirected towards the begin abutment, causing scour along both of these areas. Worst scour is at the Begin Right Corner of abutment with the wingwall to a depth of 3.5'; steel sheeting protects this corner, no undermining. This is approximately 1' deeper than the 2018 inspection.

Attachment Description:
Begin Abutment Footing /
Scour

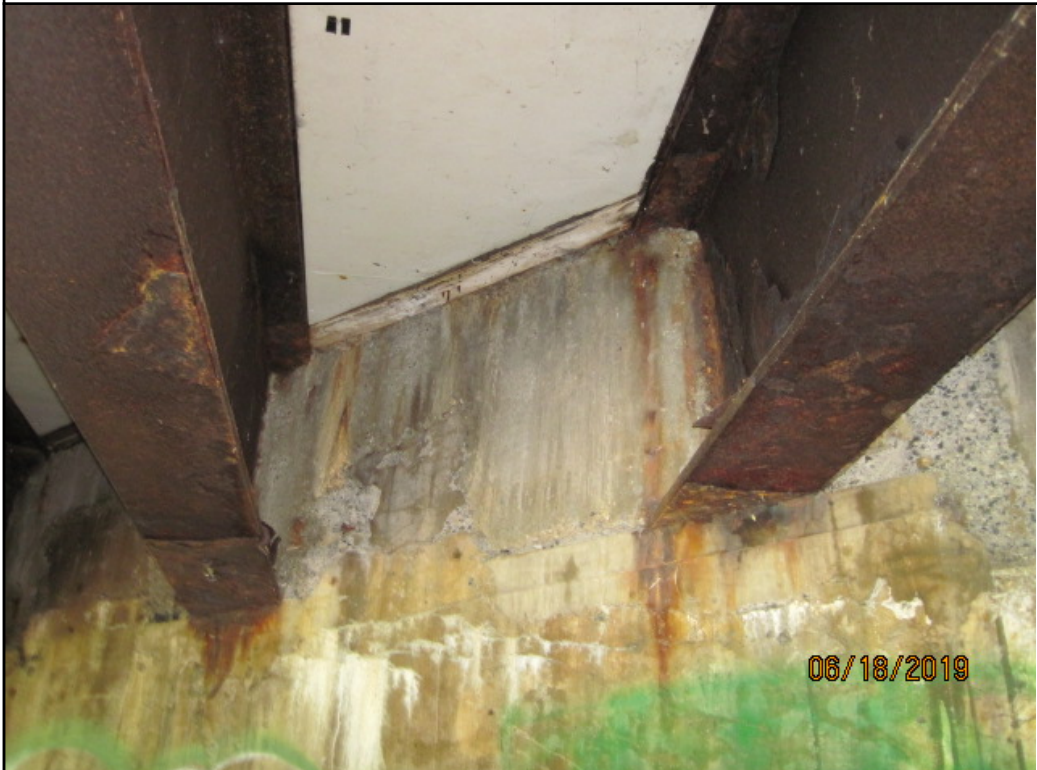
Photo Number: 4

Span 1: BA850 - Backwall	TQ	CS-1	CS-2	CS-3	CS-4	CS-5
	39	0	34	5	0	0
Condition State 3 Note Referenced Photo(s): 4 Referenced Sketch(es): None						
Begin backwall bay #2 is cracked, delaminated and spalled full bay width x full bay height x up to 2"D, similar to 2018 inspection.						
Span 1: EA850 - Backwall	TQ	CS-1	CS-2	CS-3	CS-4	CS-5
	39	0	14	25	0	0
Condition State 3 Note Referenced Photo(s): 12, 16 Referenced Sketch(es): None						
End abutment backwall is cracked, delaminated and starting to spall up to 2"D in all bays. There is heavy spalling and cracking adjacent to both fascia girders on end abutment, See Yellow Flag 1B19RPW008.						
Span 1: BA851 - Abutment Pedestal	TQ	CS-1	CS-2	CS-3	CS-4	CS-5
	7	0	6	1	0	0
Condition State 3 Note Referenced Photo(s): 5 Referenced Sketch(es): None						
Left fascia pedestal is spalled 11W X 1'H X up to 1"D, remaining concrete is sound. Similar to the last inspection in 2018.

Attachment Description:
Begin Abutment Bay 2
Backwall

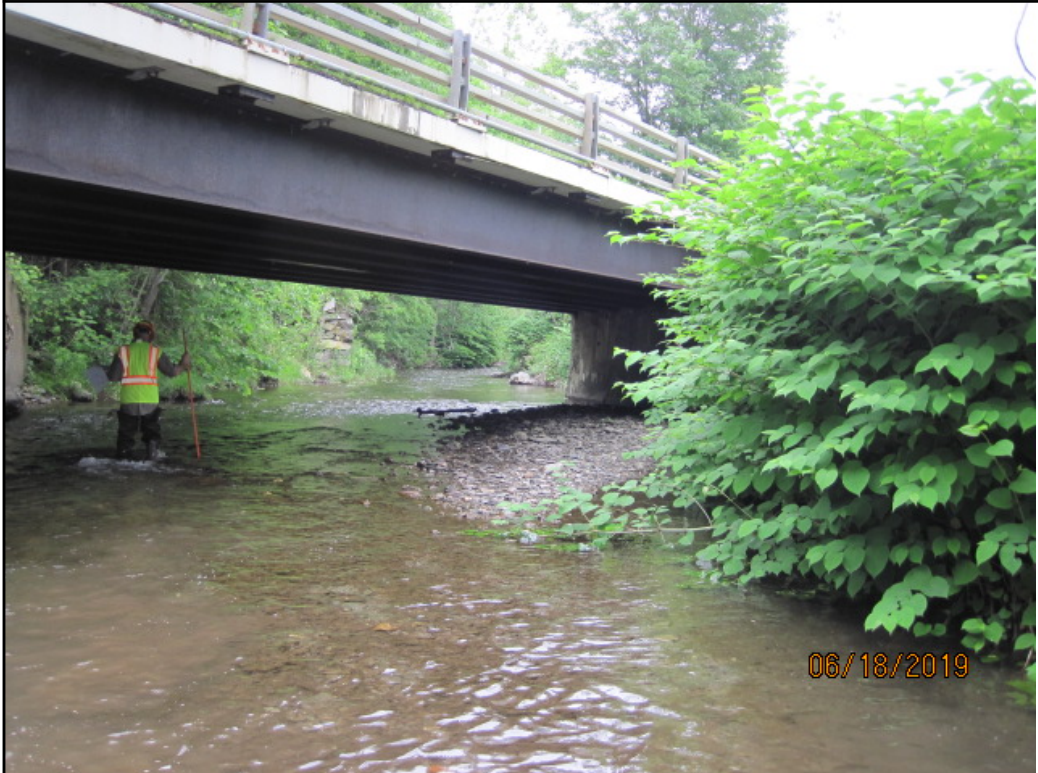
Photo Number: 7

Span 1: 801 - Stream Hydraulics	TQ	CS-1	CS-2	CS-3	CS-4	CS-5
	1	0	0	1	0	0
Condition State 3 Note Referenced Photo(s): 7, 19 Referenced Sketch(es): None						
The stream approaches towards the end left abutment and is redirected towards the begin abutment, causing scour along both of these areas and depositing silt and gravel along the End Abutment

Attachment Description:
Waterway Opening @ End
Abutment

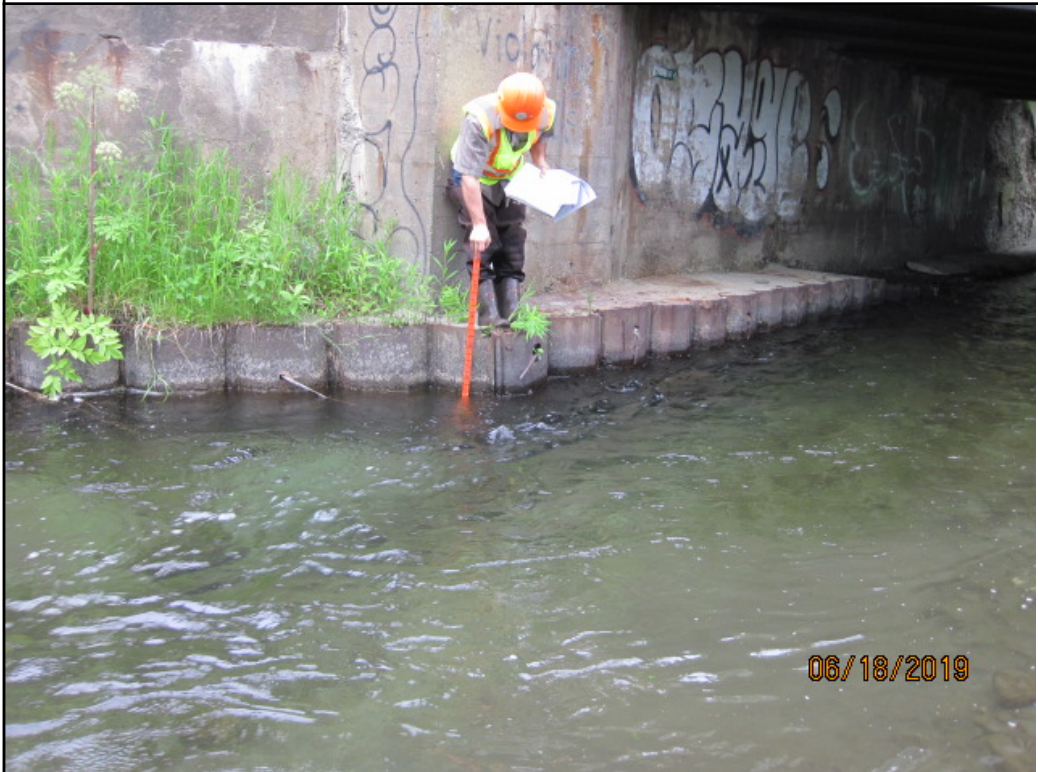
Photo Number: 8

Attachment Description:
Begin Right Abutment /
Wingwall Scour

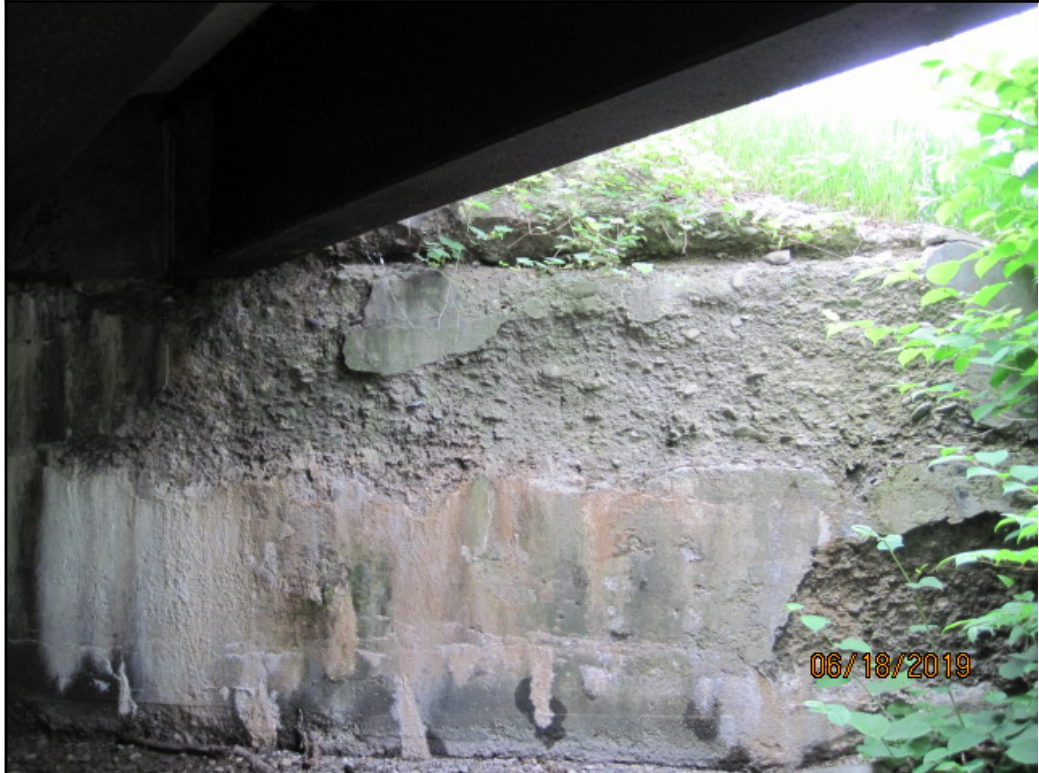
Photo Number: 11 Photo Filename: IMG_5057.JPG

Span 1: EA215 - Reinforced Concrete Abutment	TQ	CS-1	CS-2	CS-3	CS-4	CS-5
	75	0	26	49	0	0
Condition State 3 Note Referenced Photo(s): 11, 13, 14, 15, 16, 17, 18 Referenced Sketch(es): None End Right Abutment / wingwall is spalled over most of the surface from right fascia girder right to the end of the wingwall, up to 8'H X 6"D. There is also a large, full-height crack under G4. Conditions appear similar to the last inspection in 2018. There is heavy spalling and cracking adjacent to both fascia girders on end abutment, See Yellow Flag 1B19RPW008.

Span 1: EA851 - Abutment Pedestal	TQ	CS-1	CS-2	CS-3	CS-4	CS-5
	7	0	5	2	0	0
Condition State 3 Note Referenced Photo(s): 11, 14, 16, 17, 18 Referenced Sketch(es): None						
There is heavy spalling and cracking adjacent to both fascia girders on end abutment, See Yellow Flag 1B19RPW008.						
Span 1: BW853 - Wingwall	TQ	CS-1	CS-2	CS-3	CS-4	CS-5
	15	0	0	15	0	0
Condition State 3 Note Referenced Photo(s): 6 Referenced Sketch(es): None						
Begin right wingwall is cracked and delaminated over most of its surface, with spalling in various locations up to 3"D.

Attachment Description:
End Right Abutment / Right
Fascia Pedestal

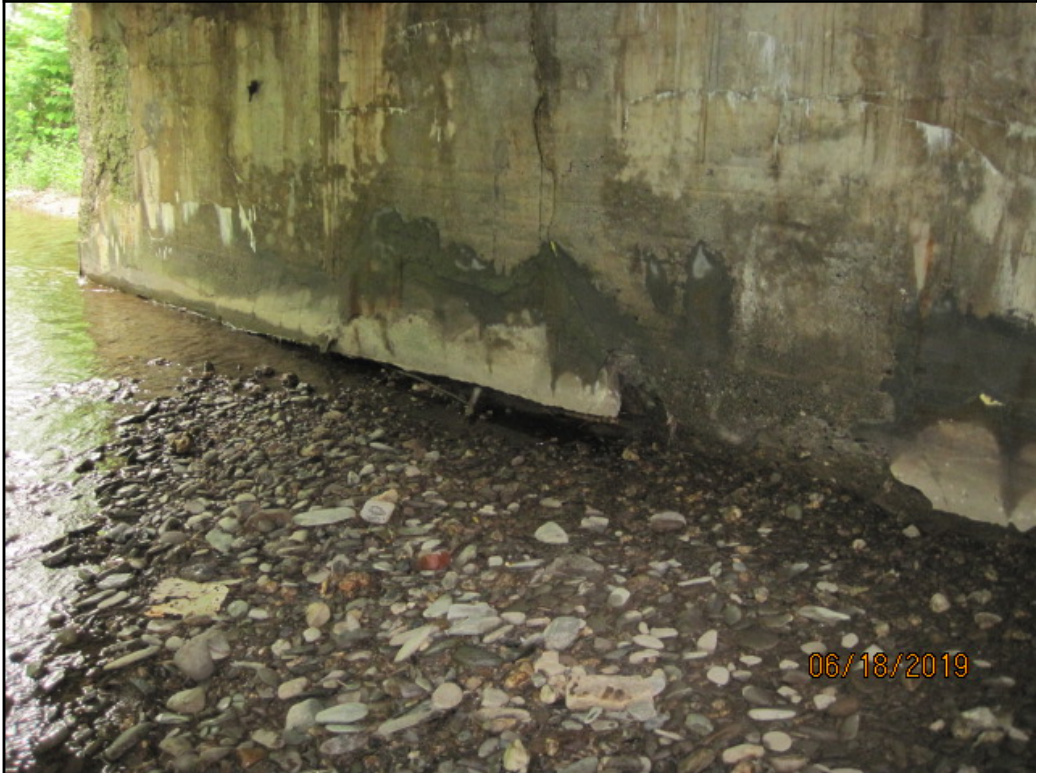
Photo Number: 13 Photo Filename: IMG_5059.JPG

Attachment Description:
End Left Abutment / Scour

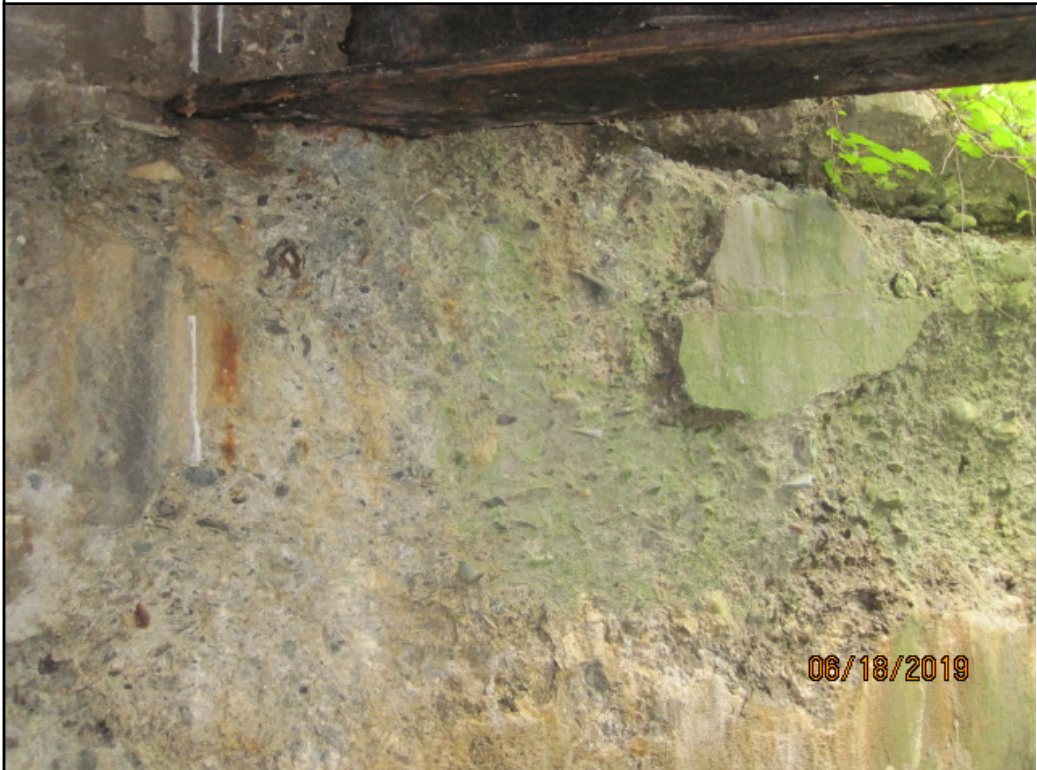
Photo Number: 14 Photo Filename: IMG_5060.JPG

Attachment Description:
End Right Abutment / Right
Fascia Pedestal

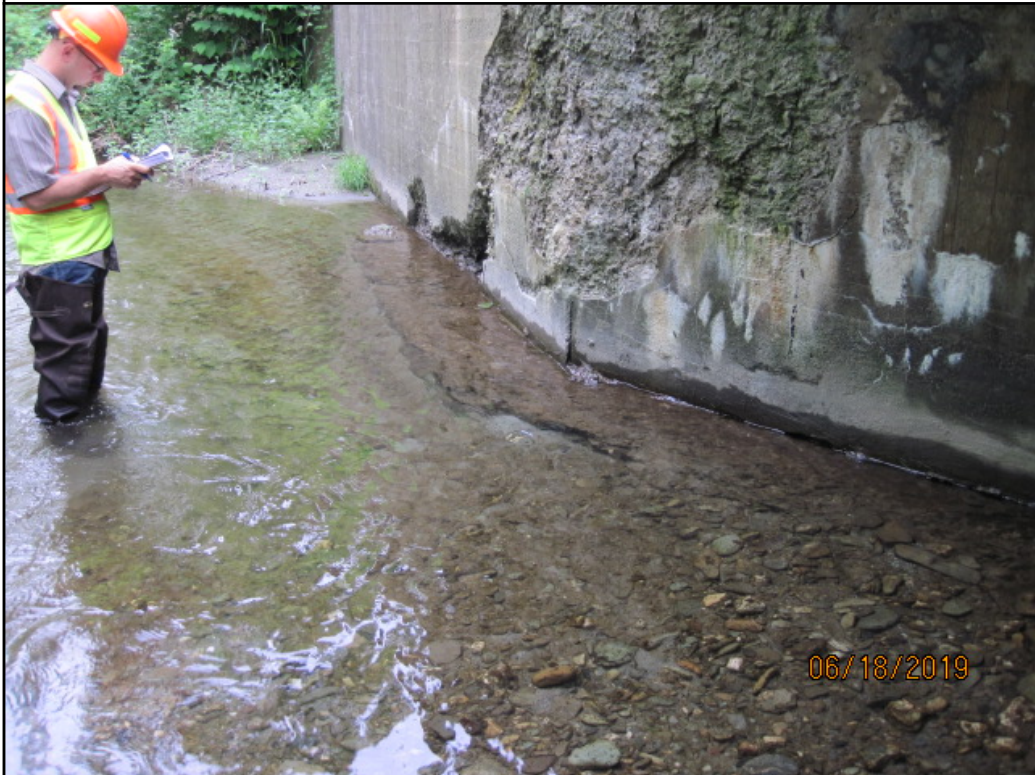
Photo Number: 15

Attachment Description:
End Left Abutment / Footing
/ Scour

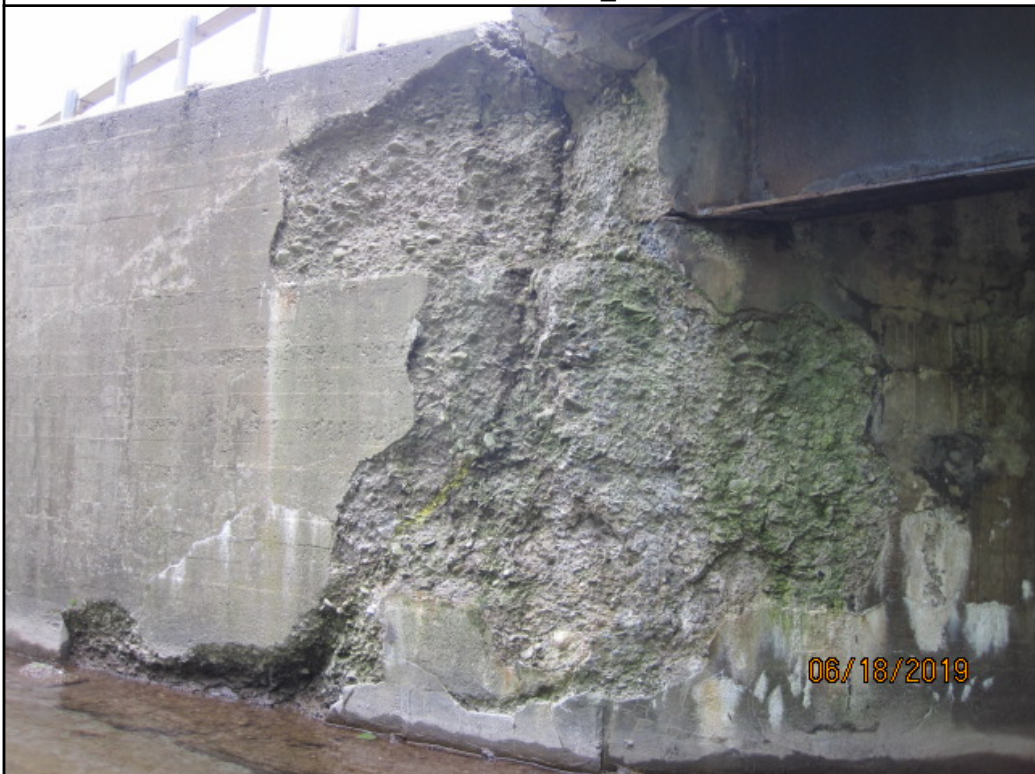
Photo Number: 16

Attachment Description:
End Left Abutment /
Backwall / Left Fascia
Pedestal

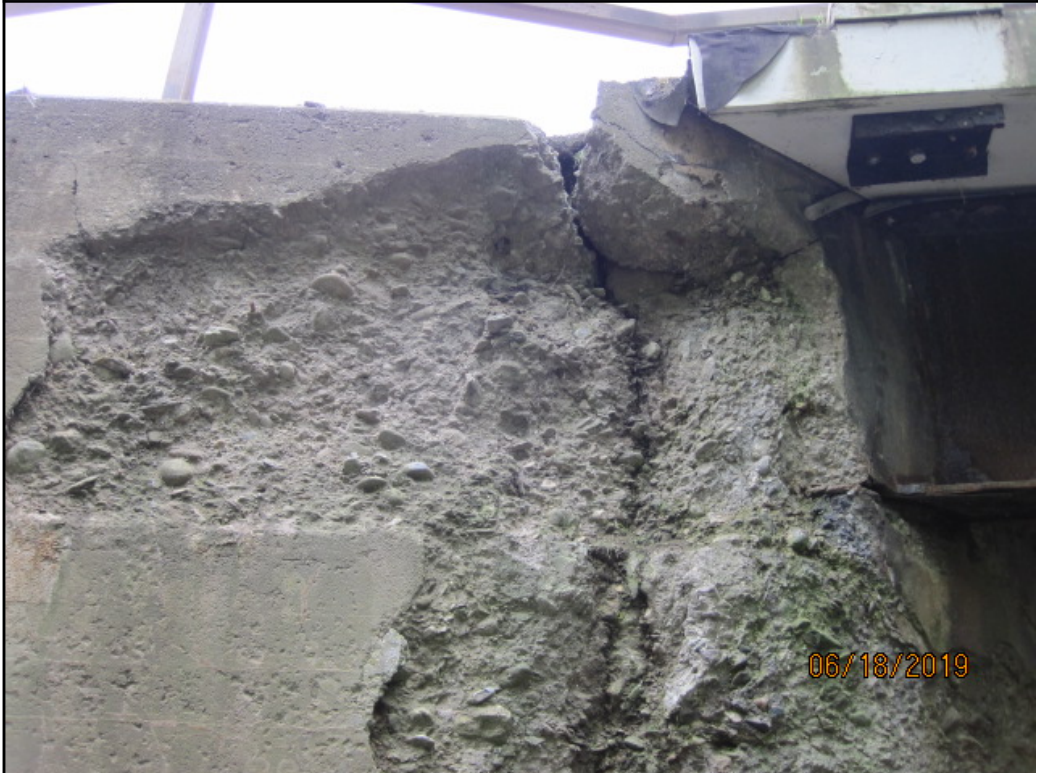
Photo Number: 17

Attachment Description:
End Left Upper Abutment /
Left Fascia Pedestal

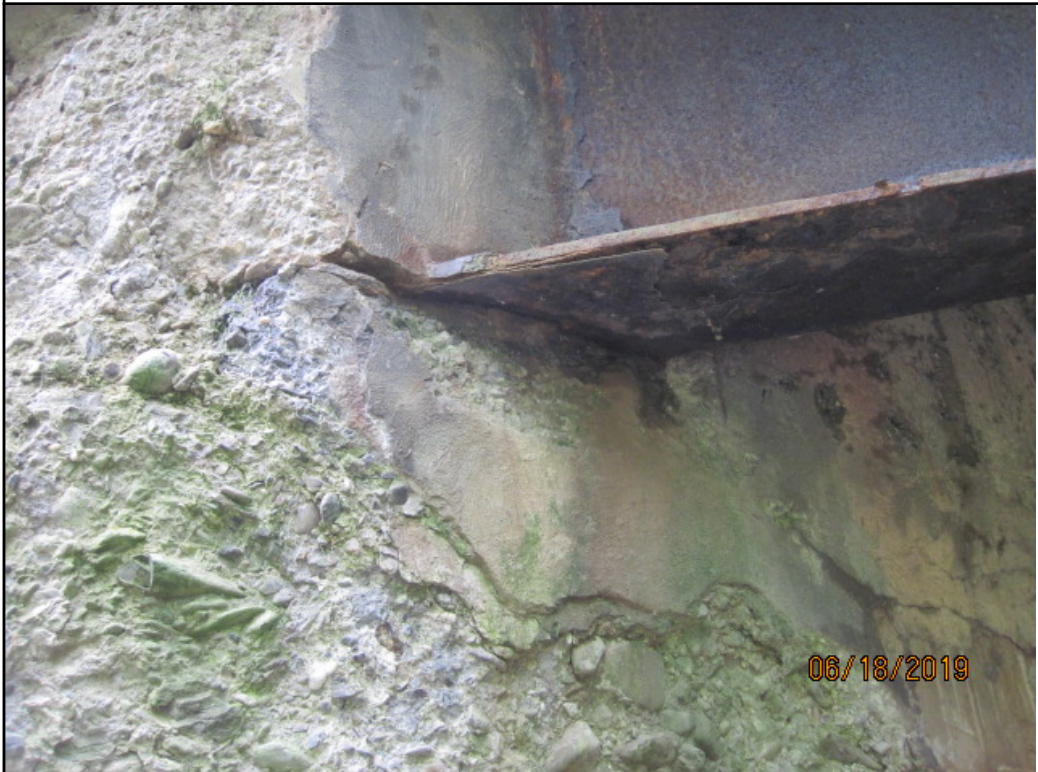
Photo Number: 18

Attachment Description:
End Left Upper Abutment /
Left Fascia Pedestal

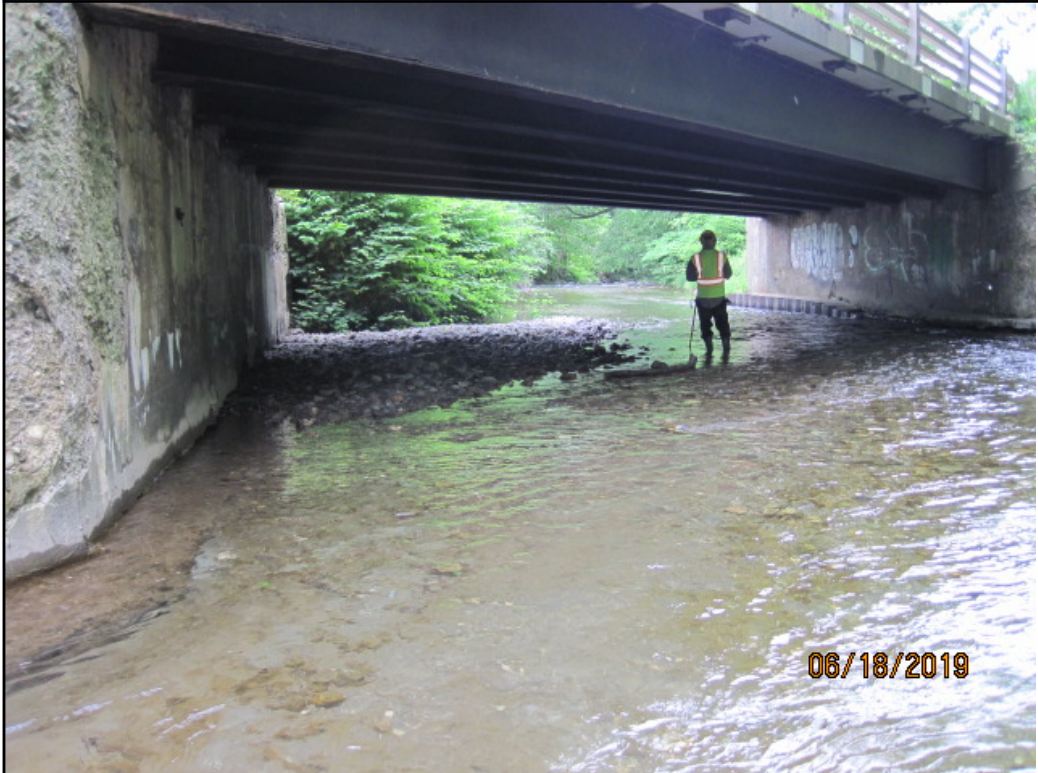
Photo Number: 19

Attachment Description:
Waterway Opening @ End
Abutment

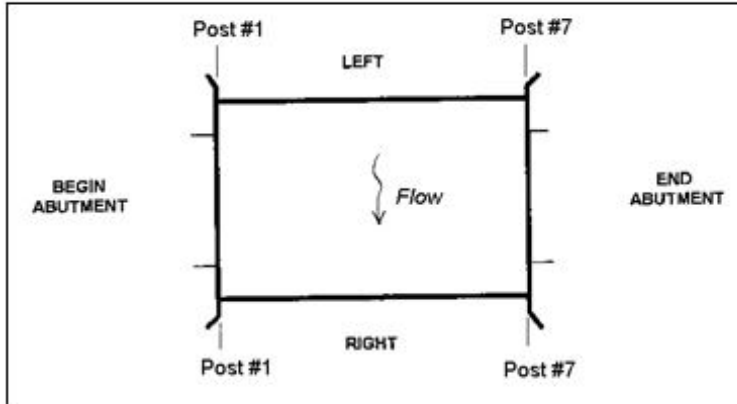
CHANNEL CROSS-SECTIONS
ALONG FASCIAS (FEET)

REFERENCE	YEAR	NOTES
	2015	Readings taken to top of rail. Rail height = 2.9'. Begin footing exposed full length. End footing exposed at left wingwall & most of abutment. Water clear, minor scour with no significant changes from previous readings.
	2016	Water clear, <1.5' deep with no significant changes from previous readings. Abutment footings exposed with minor scour at begin right and end left.
	2017	Water clear, <1.5' deep with no significant changes from previous readings. Abutment footings exposed with minor scour at begin right and end left.
	2018	no significant changes from previous readings. Abutment footings exposed with minor scour at begin right and end left.
	2019	Water clear. Some minor changes to left and right-side readings. Right side readings at rail post 2 1.2' deeper. Water @ rail post 2 right side 2.0'. Abutment footings exposed with minor scour at begin right and end left.

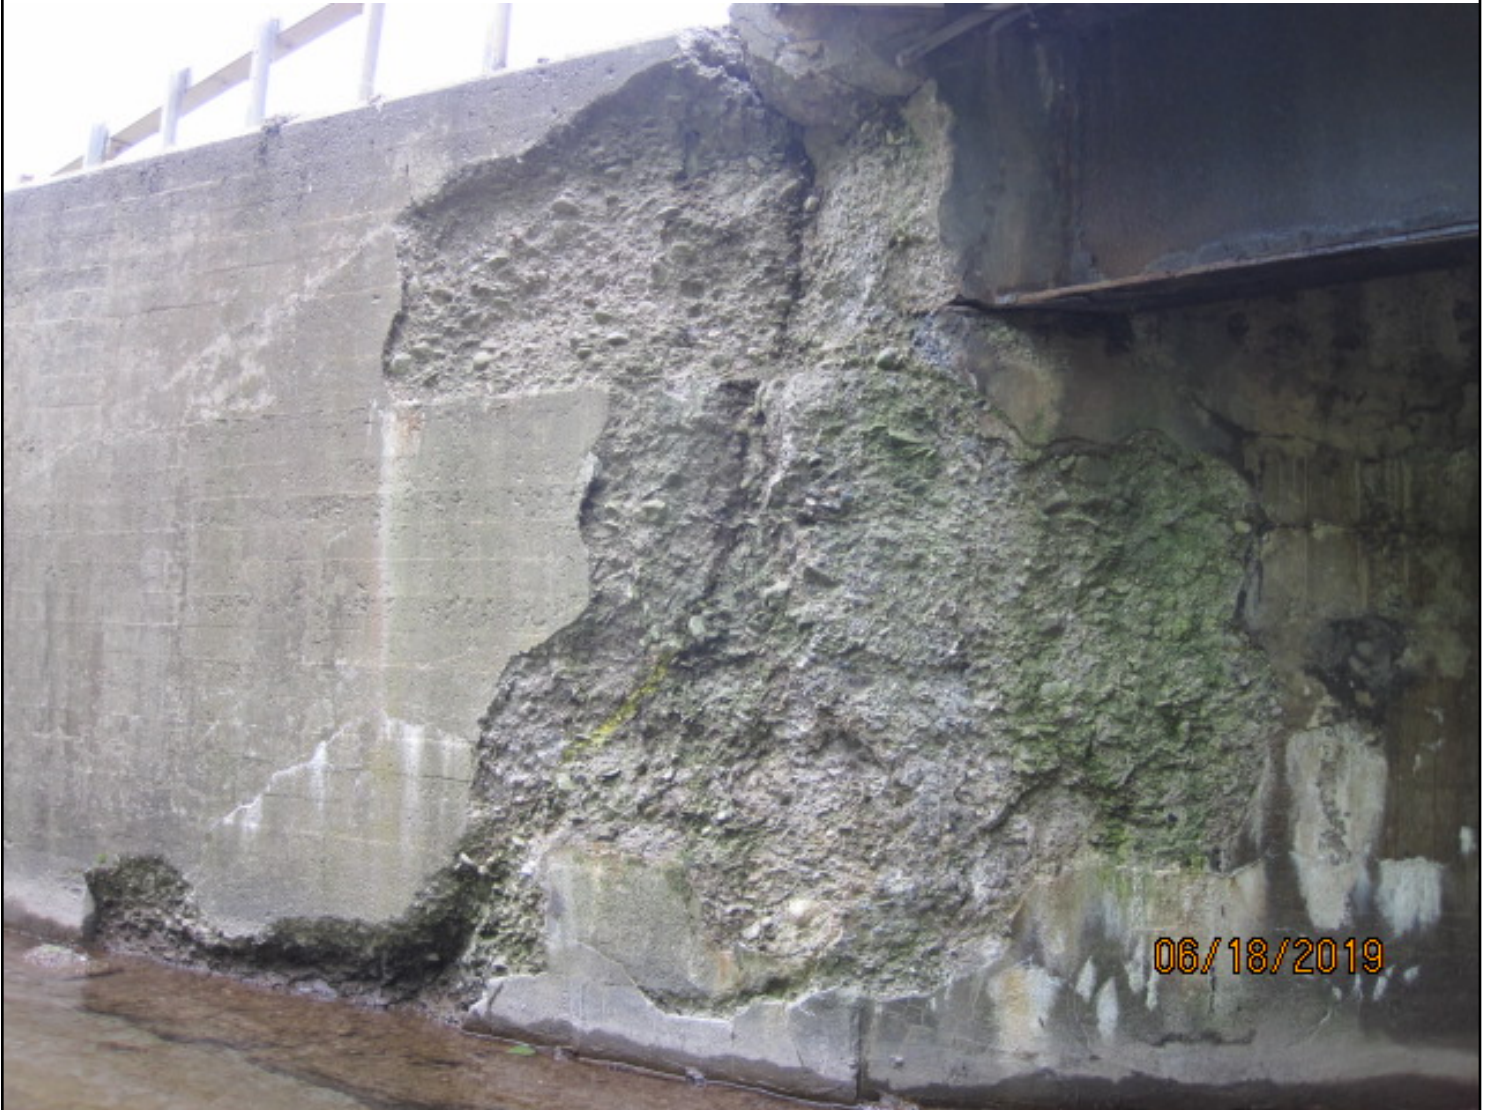
Photo Number: **1**

Abutment / Wingwall is cracked, delaminated and spalled over most of its surface. The spall is up to 16"L X full abutment height X up to 1"D; worst along the top 5' of the abutment, exposing original backwall at left edge of girder. Embedment depth is unknown, concrete cover to the left of left fascia girder is 1.5'W ft wide (measured perpendicularly from left web face) x 2.75'H x unknown depth. Embedment cover over left side of left fascia girder has cracks that run from both top and bottom flanges to left face of backwall and vertical crack. Bottom 6' of spall is less deep with a maximum spall depth of up to 6". Spall undermines left fascia girder for full-girder width x 6"H X up to 1"D; remaining concrete in this vicinity is sound. A crack runs adjacent to left fascia girder down diagonally through spall to footing. These conditions appear similar to the last inspection in 2018.

Attachment Description: End Left Abutment, Backwall and Pedestal

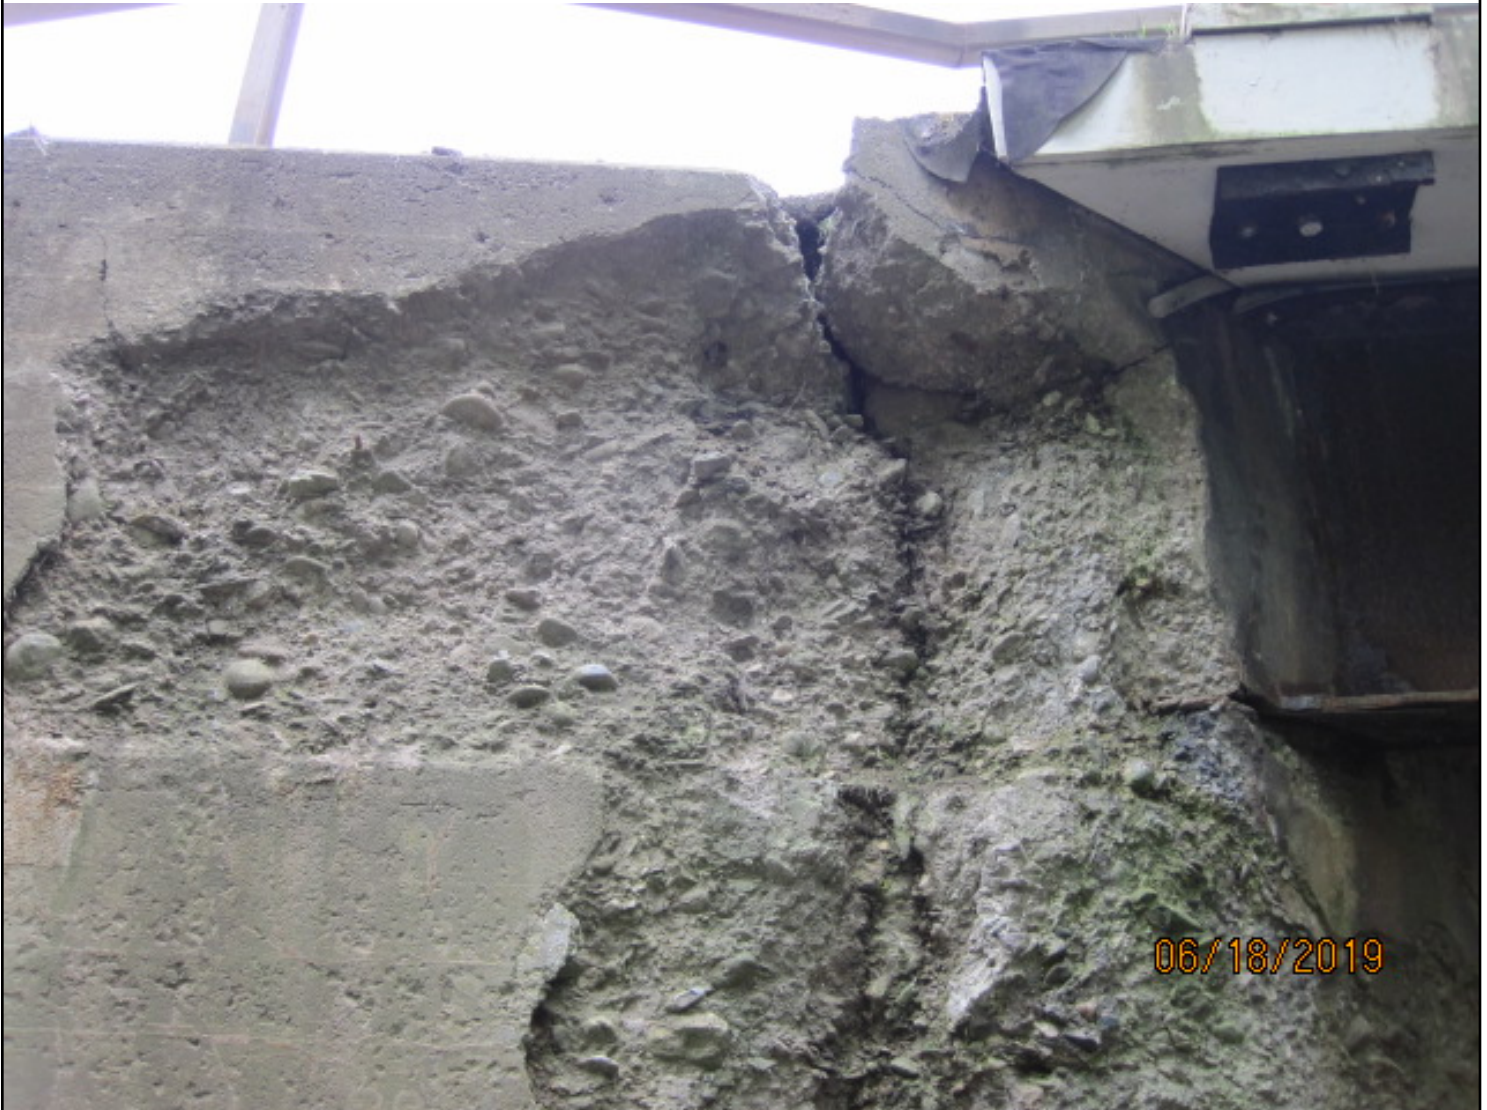
Photo Number: 2

Attachment Description: End Left Abutment, Backwall and Pedestal Close up

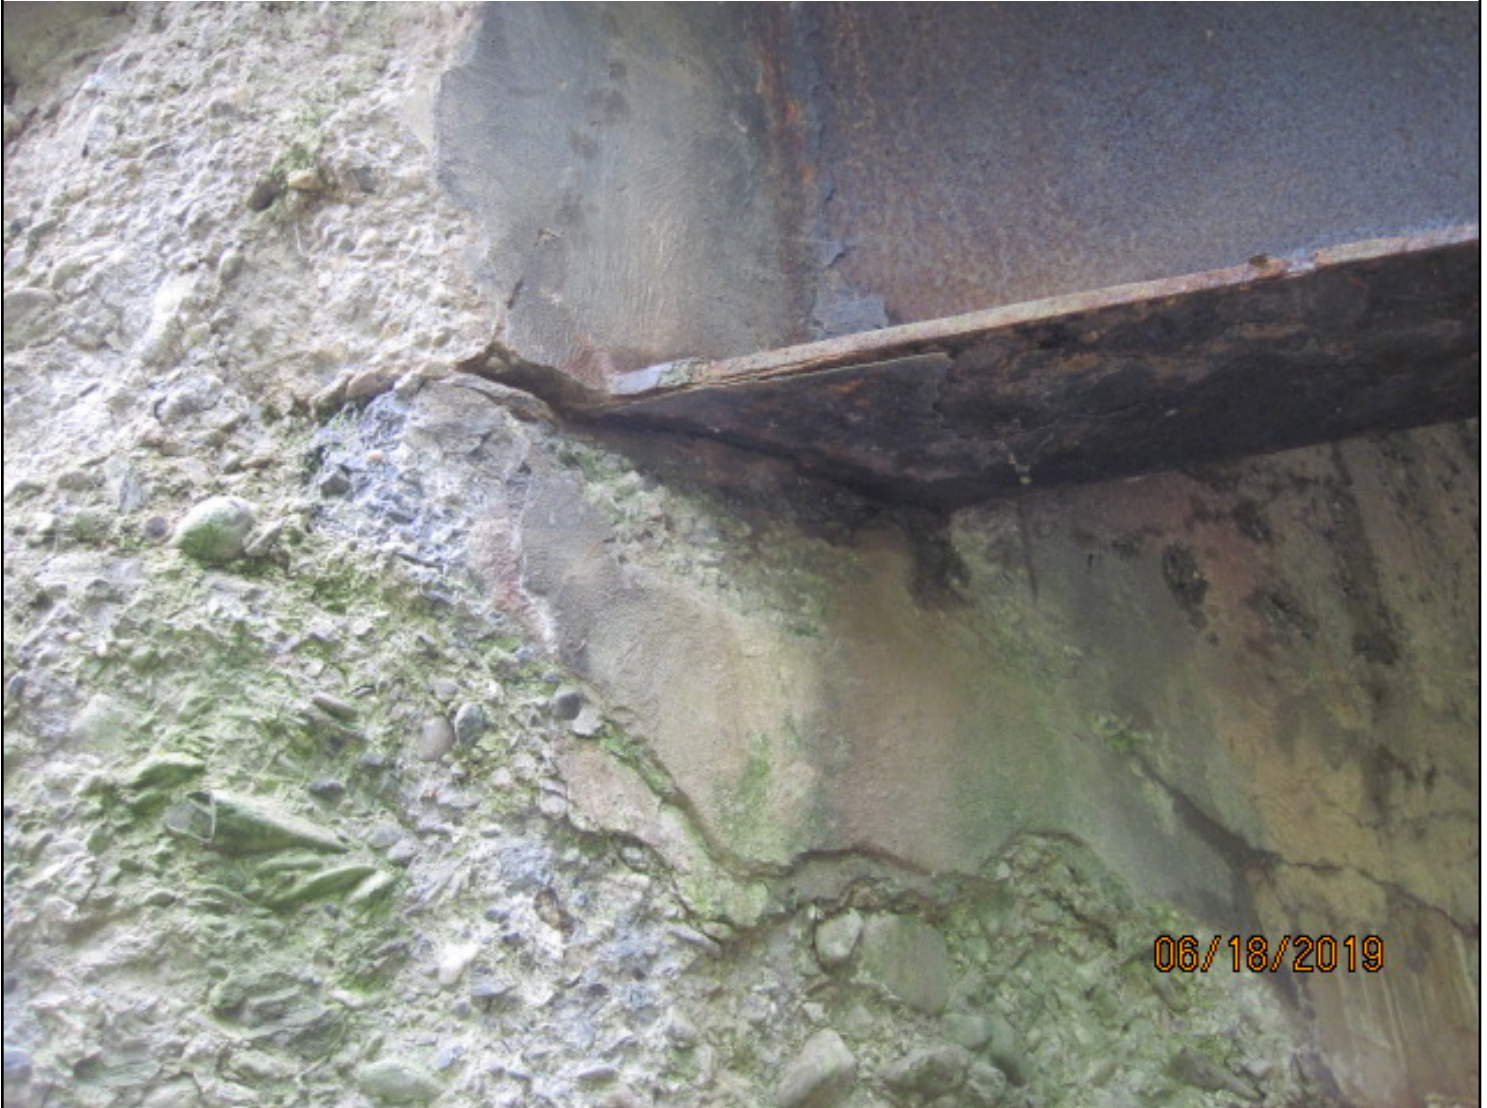
Photo Number: 3

Attachment Description: End Left Abutment and Pedestal

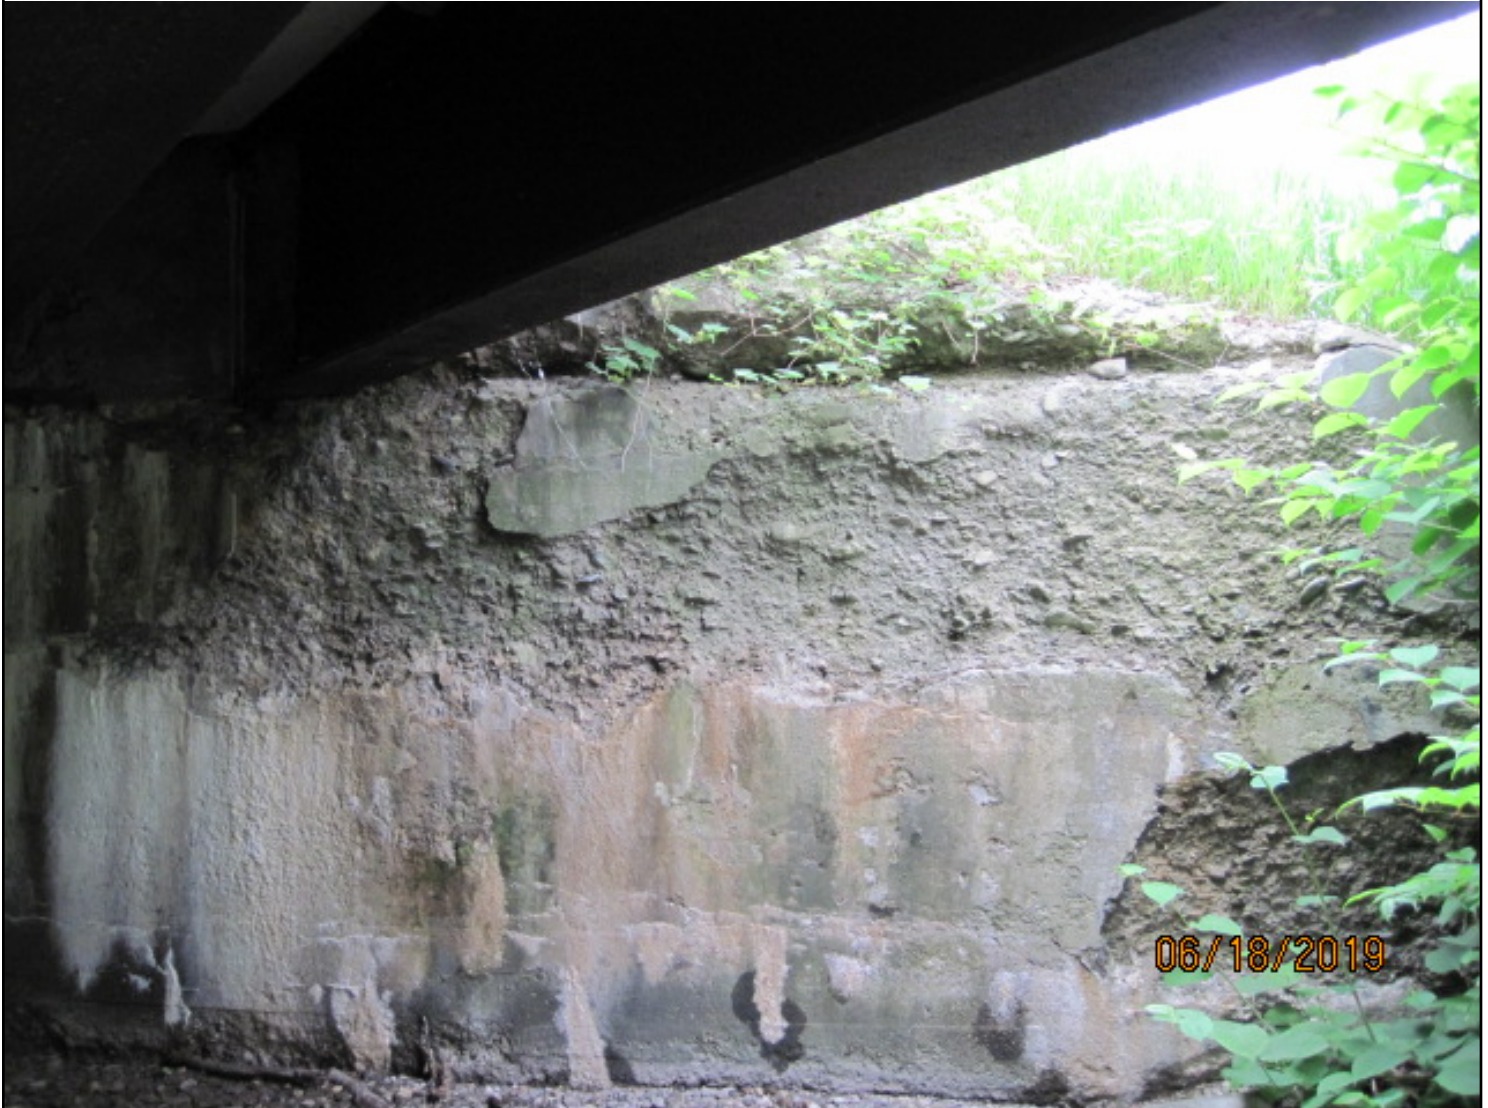
Photo Number: 4

Abutment / Wingwall is delaminated and spalled. Delaminations and spalls extend from under right fascia girder to end of abutment / wingwall. The spall is up to 18'L X 6'H X up to 8"D. Spall undermines right fascia girder for full girder width x 3"D; remaining concrete in the vicinity is sound. Embedment length of Girders is unknown. These conditions appear similar to the last inspection in 2018.

Attachment Description: End Right Abutment and Pedestal

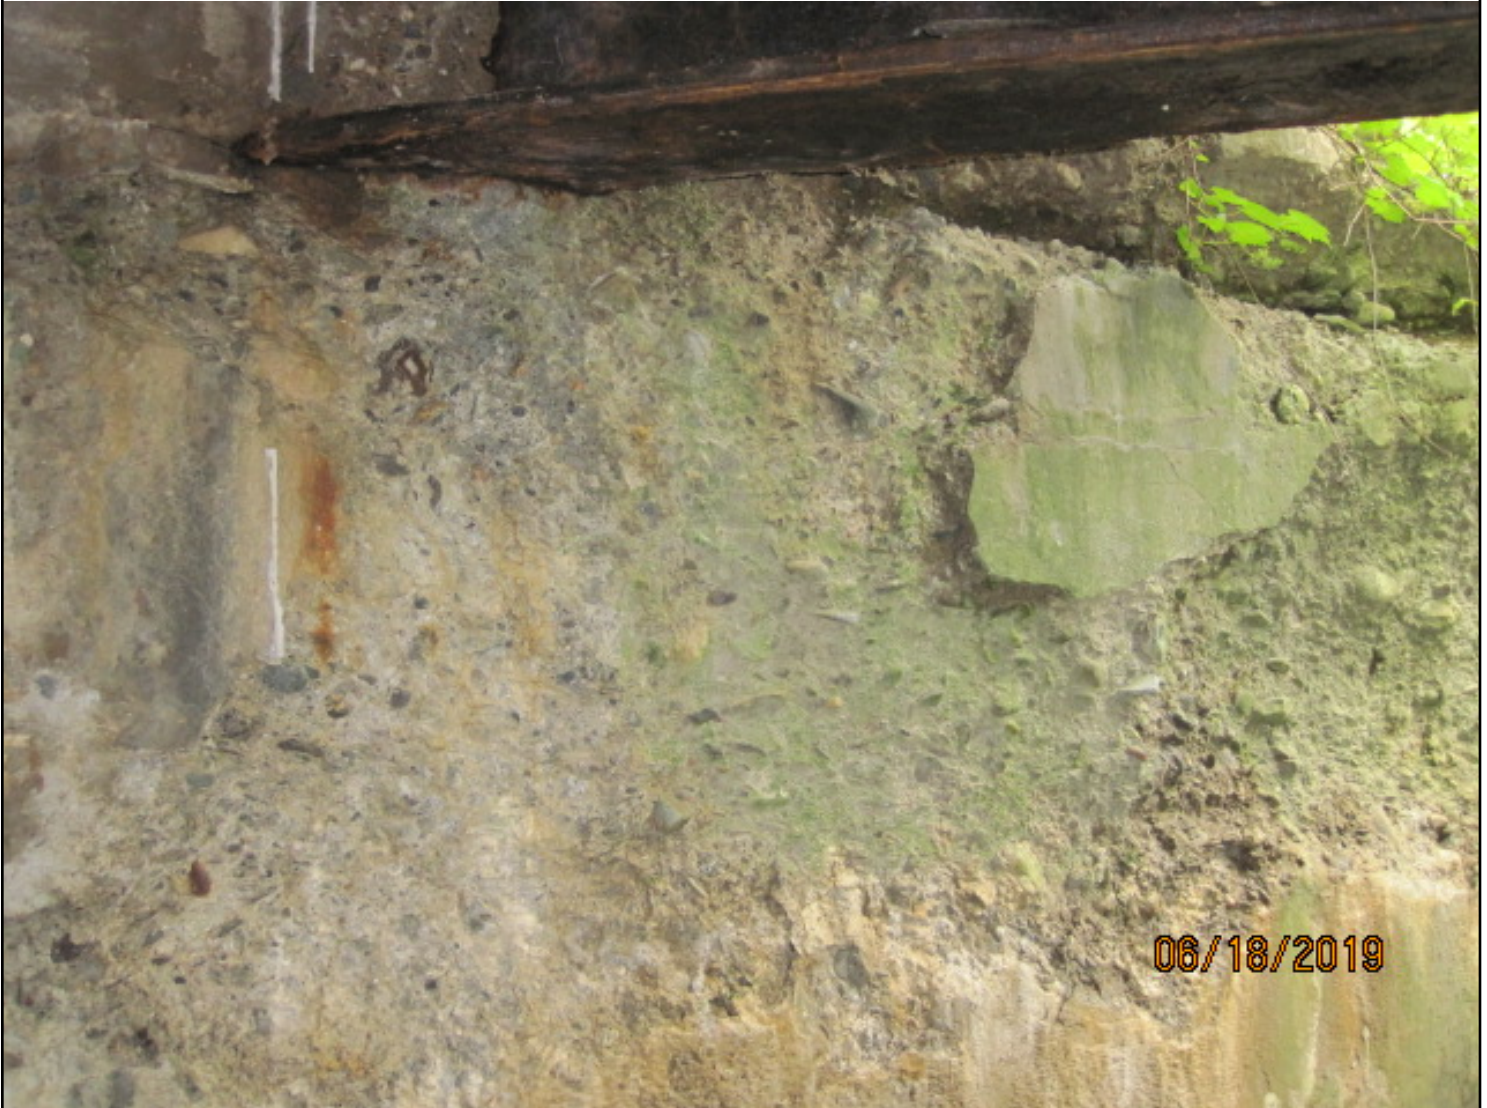
Photo Number: 5

Attachment Description: End Right Abutment, Backwall and Pedestal
